Manhole Inspection Summary

Manhole # S21K__052MH

Location Address: **1803 wilhelm st** Cross Street: **fulton-addison alley**

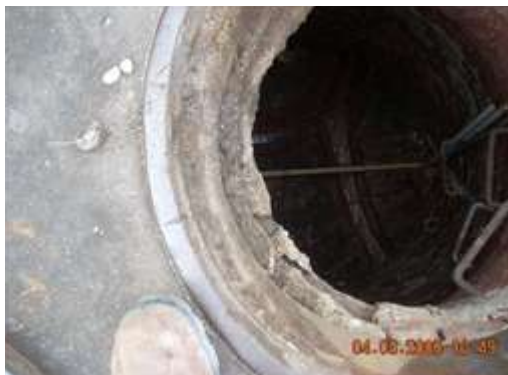
Defect 1

Frame Offset: **1** (in.) Condition: ☒ Sound ☐ Cracked ☐ Leaks

frame offset, debris on bench

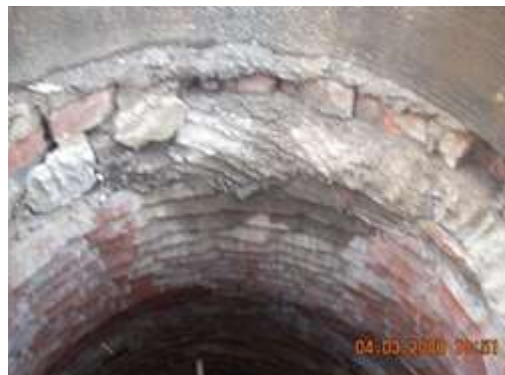
Defect 3

Infiltration: ☐ None ☒ **Joint** ☐ Cracks ☐ Mortar ☐ Roots ☐ Wall

infiltration @ chimney joint

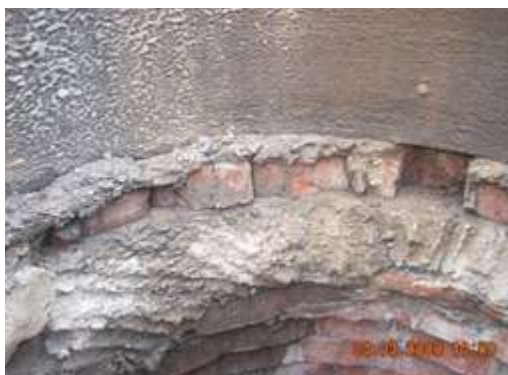
Defect 2

Condition: ☐ Sound ☒ **Cracked** ☐ Root Intrusion ☐ Loose Brick ☐ Deteriorated

cracked chimney bricks, chimney parged

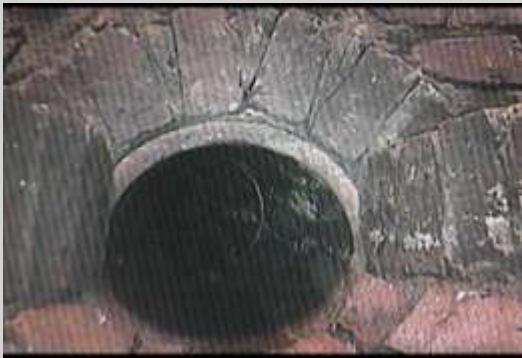
12 O'Clock Outflow

Pipe Height: **8.4** (in.) Rod and Bar (Angled)
Pipe Material: **Clay** ☐ Pipe Lined
Invert Depth: **8.12** (ft.) Flow Characteristics: **Slow**
Deposits: ☒ None ☐ Mud ☐ Sludge ☐ Debris ☐ Grease
Silt Depth: **0** (in.) Deposits Extent:
Infiltration: **None** Pipe Seal Cond: **Sound**

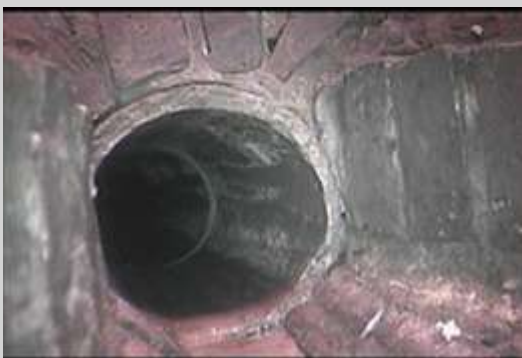
4 O'Clock Inflow

Pipe Height: **6** (in.) Rod and Bar (Angled)
Pipe Material: **Clay** ☐ Pipe Lined
Invert Depth: **7.75** (ft.) Flow Characteristics: **Slow**
Deposits: ☒ None ☐ Mud ☐ Sludge ☐ Debris ☐ Grease
Silt Depth: **0** (in.) Deposits Extent:
Infiltration: **None** Pipe Seal Cond: **Sound**

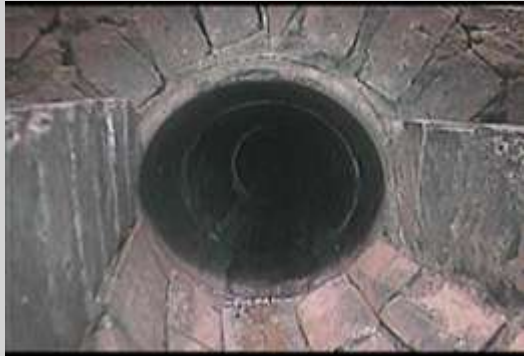
9 O'Clock Inflow

Pipe Height: **7.2** (in.) Rod and Bar (Angled)

Infiltration: **None** Pipe Seal Cond: **Sound**
